**South 4 Group Fire at PNO**

**TPC Group LLC**

**August 5, 2020**

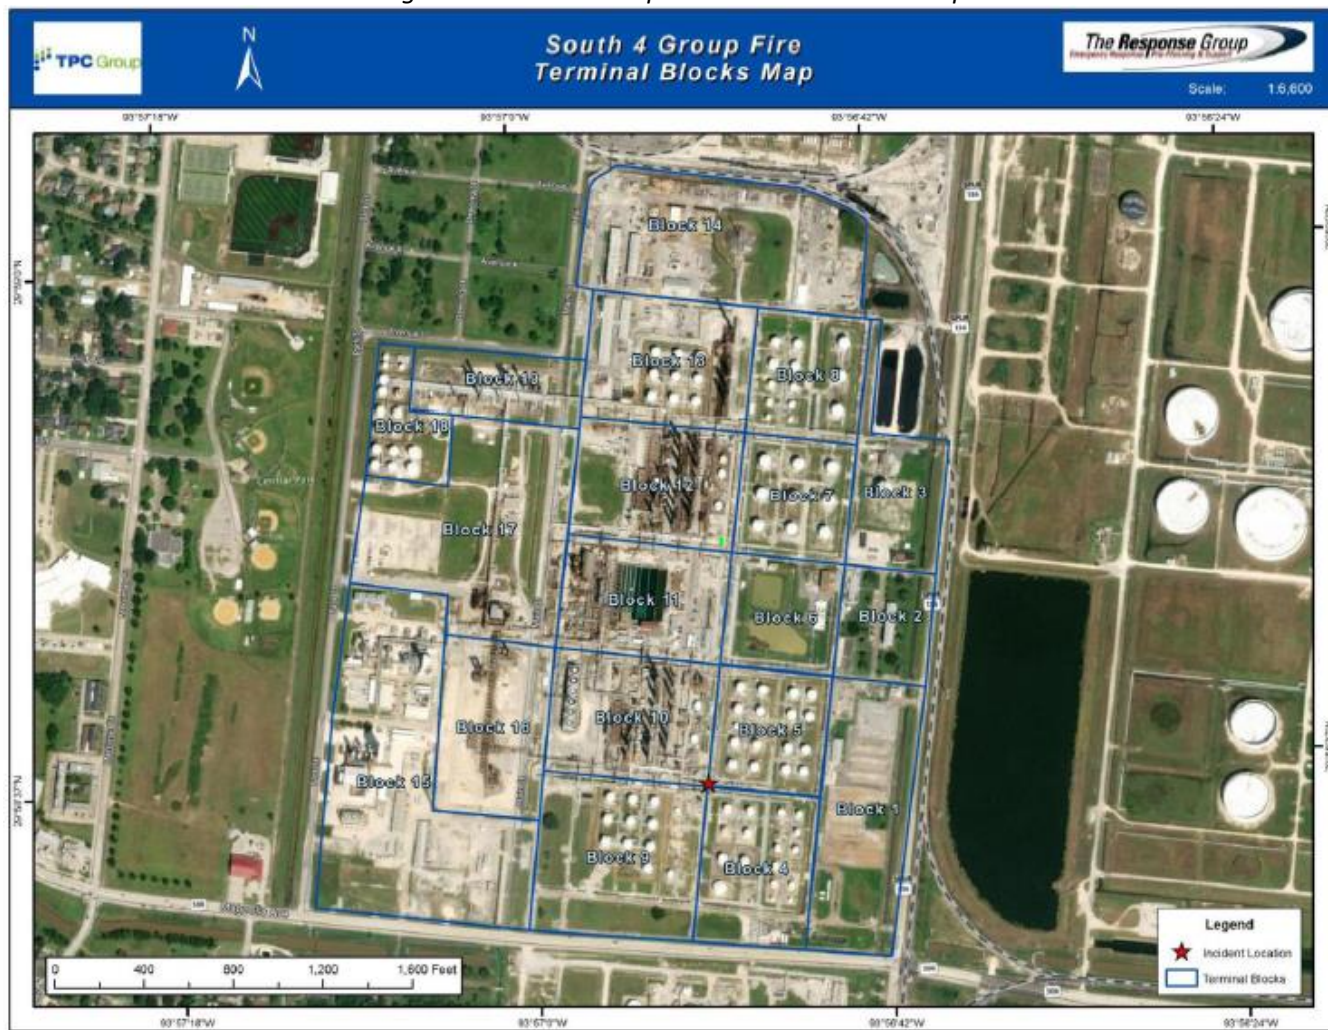
Figure 3: South 4 Group Fire Terminal Blocks Map

The following photo provides a view of the facility, with Blocks indicated, prior to the event.

Baker Risk was hired to assess all buildings on site and rank according to structural damage. Additionally, Baker Risk performed a hazard assessment on the damaged Blocks to determine remaining hazards and fall potential of equipment still standing, including developing a fall radius for the towers. An Exclusion Zone was established around Blocks 5 and 10 whereby entrance was prohibited without explicit authorization.

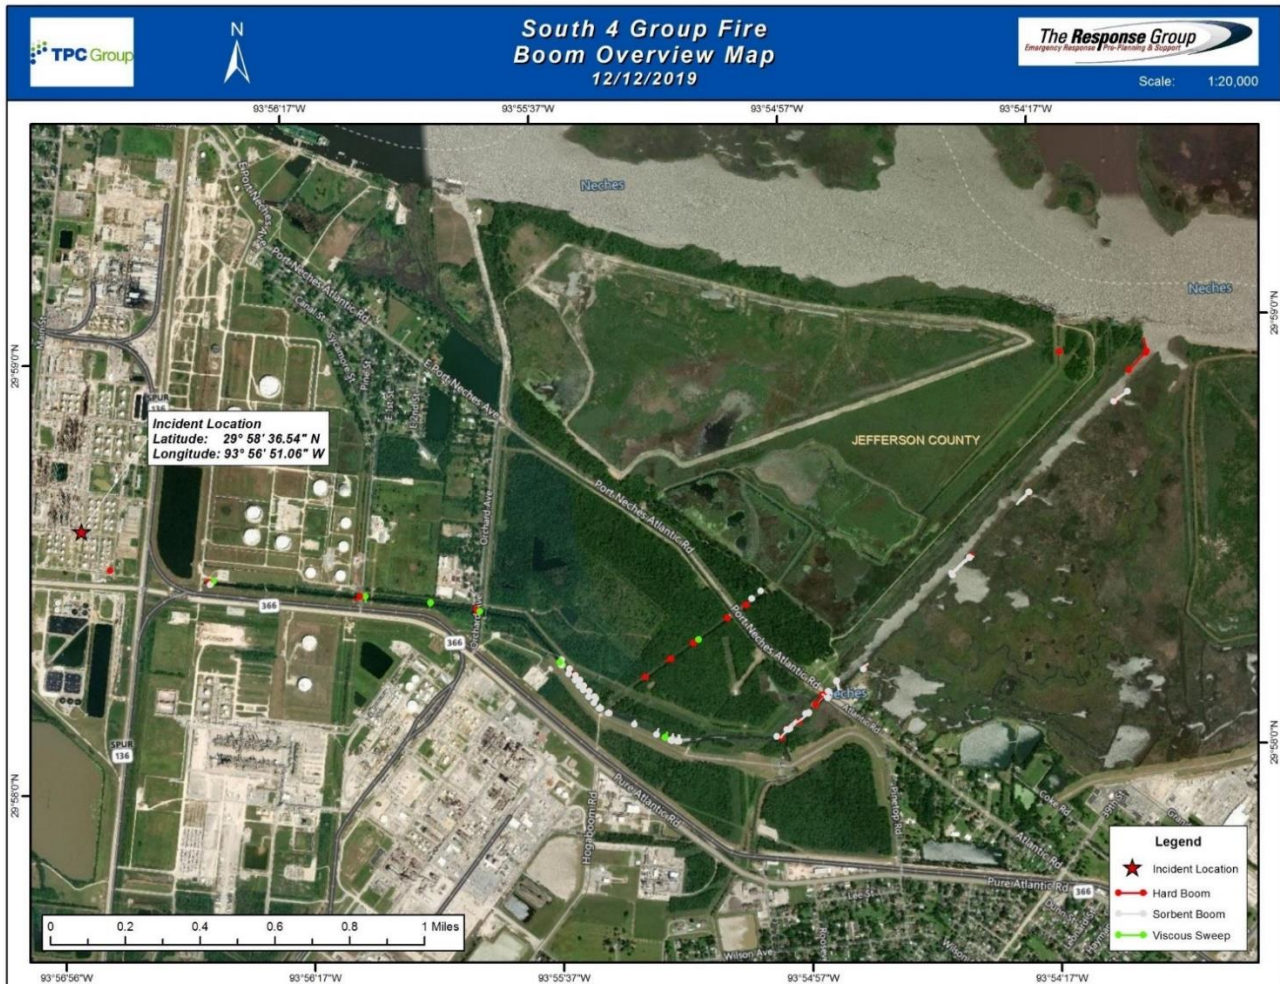
Figure 7: South 4 Group Fire Boom Overview Map (12/12/2019)

A series of booms and absorbents were placed in series along the canal to prevent the release of hydrocarbons to the Neches River. The OSRO contractor utilized hard booms, soft booms, viscous sweep, skimmer equipment, oil absorbent mop jon boats and vacuum trucks to collect the floating hydrocarbons. This figure shows the placement of the booms. The vacuum trucks, usually three in service, were stationed at Pine and Orchard Streets.

Alternately, the water can be directed by Indorama to their tertiary treatment section, which also discharges into the Neches River. During the response period, the canal was divided into five sections, A through E, in order to efficiently manage response efforts. *See Surface Water Sampling Flow Paths* on Page 53 of Appendix G for the boundaries for divisions. A series of booms and response equipment including vacuum trucks, Jon boats and skimming devices were used to collect and containerize contaminated material prior to reaching the Neches River. The *Boom Overview Map*, Figure 7 in Appendix A, depicts the locations that the OSRO contractor placed a variety of booms and other mitigation measures.
